MASTERGRAIN™
REDEFINING THE ENTRY DOOR

Thermal Testing Results

*Testing completed on 35.75 x 83 Six Panel Oak Grain Slab.
Testing performed and documented by Weber Manufacturing Technologies Inc.*

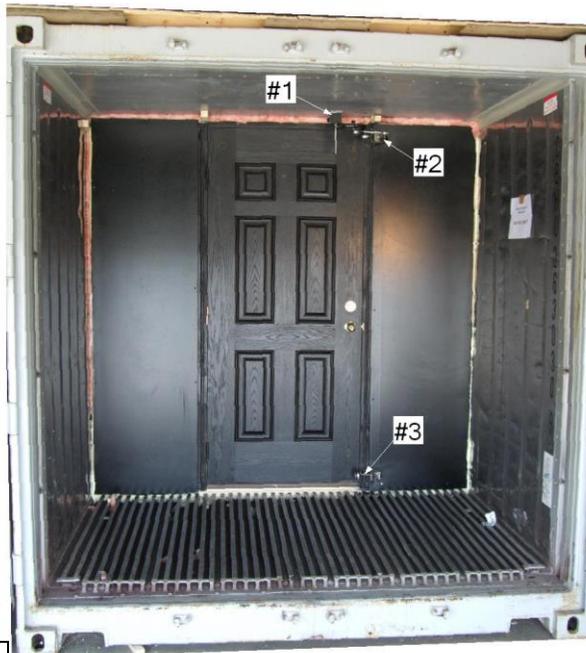
A 2x6 stud wall with door assembly was installed into a refrigeration unit, which was fully insulated and sealed. The inside of the unit was to simulate outdoor temperature extremes as seen in severe winter conditions and the outside of the container would represent the inside conditions of a home. All holes and small voids were then stuffed with batt insulation or filled with low expansion spray foam. The door clearances were no less than .060" and no greater than .100" to ensure the door was not binding prior to the test start up. All weather seals were checked for good compression and seal. The dead bolt and lock set were tested to ensure they were functioning without any interference. Prior to applying the cold temperatures to the inside of the unit we installed indicators in three positions on the door to monitor the movements under thermal differences. See Images 2-1 thru 2-3 for the indicator positions.

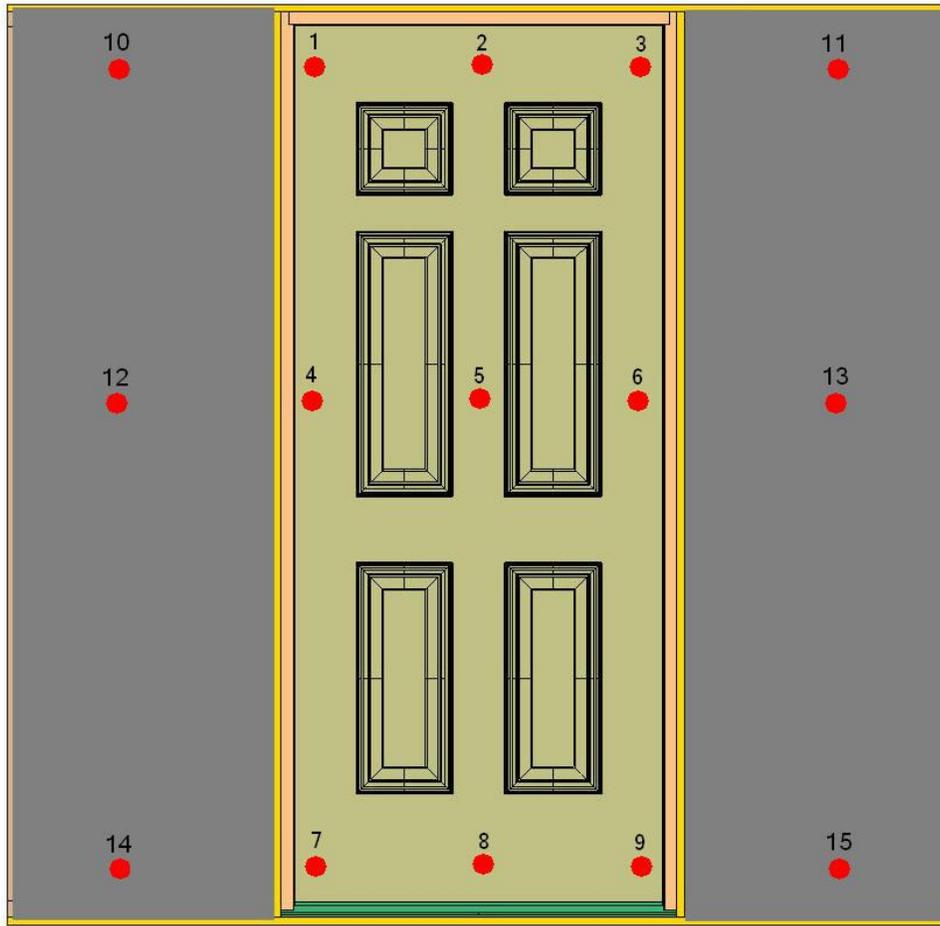
"Actual Surface Temp Checks °C" are surface locations checked with a pyrometer. See Chart on page 5

Date	Time	Inside Sensor °C	Outside Sensor °C	Points Checked on Door & Wall with Pyrometer °C														
				1	2	3	4	5	6	7	8	9	10	11	12	13	14	15
1-May-09	3:00 PM	-7.6	24.2	24.1	24.1	24.2	23.9	24.0	24.0	23.8	23.8	23.7	24.2	24.1	24.1	24.0	23.9	23.8
4-May-09	9:00 AM	-10.5	20.1	16.2	19.5	15.9	15.9	19.4	15.7	15.1	18.8	15.4	21.6	21.4	21.2	21.1	20.5	20.4
4-May-09	11:00 AM	-15.1	23.4	18.9	22.2	18.5	18.8	22.4	18.4	17.4	21.1	17.6	23.2	23.9	24.0	24.1	23.2	23.7
4-May-09	1:00 PM	-15.2	24.1	19.1	22.5	18.6	19.0	22.4	18.5	17.6	21.4	17.8	23.3	23.9	24.1	24.2	23.4	23.7
4-May-09	4:00 PM	-20.0	24.9	19.1	22.3	18.6	18.0	22.3	16.7	16.1	21.1	16.5	23.3	23.7	23.8	24.0	22.9	23.2
5-May-09	9:00 AM	-19.7	21.2	16.7	19.9	16.7	15.8	19.9	15.9	14.7	19.0	15.8	20.8	21.1	21.5	21.6	20.7	20.9
5-May-09	11:00 AM	-24.3	22.6	16.5	20.4	16.6	15.7	20.8	15.7	15.6	19.7	14.8	21.7	22.4	22.5	23.1	21.8	22.3
5-May-09	1:00 PM	-24.9	23.4	16.7	21.4	16.9	16.2	21.2	16.1	16.0	20.9	15.8	22.1	22.2	21.9	21.7	21.4	21.6

5-May-09	4:00 PM	-29.3	24.5	17.1	21.9	17.2	17.1	22.5	17.2	15.5	20.5	15.3	23.2	24.1	24.1	24.5	23.5	23.8

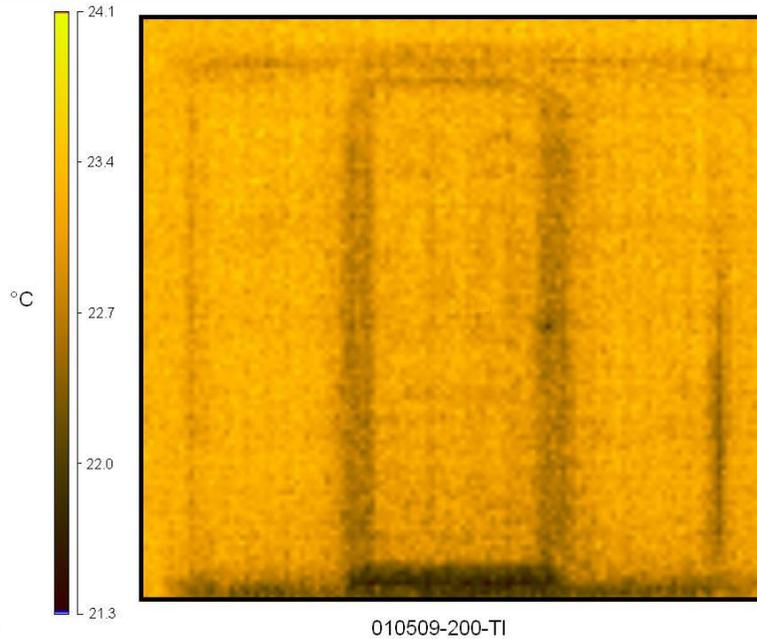
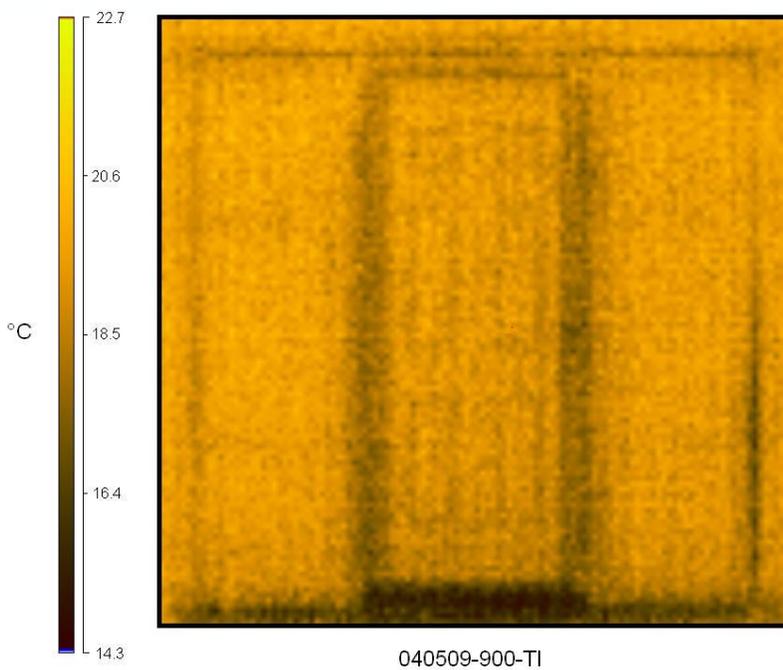
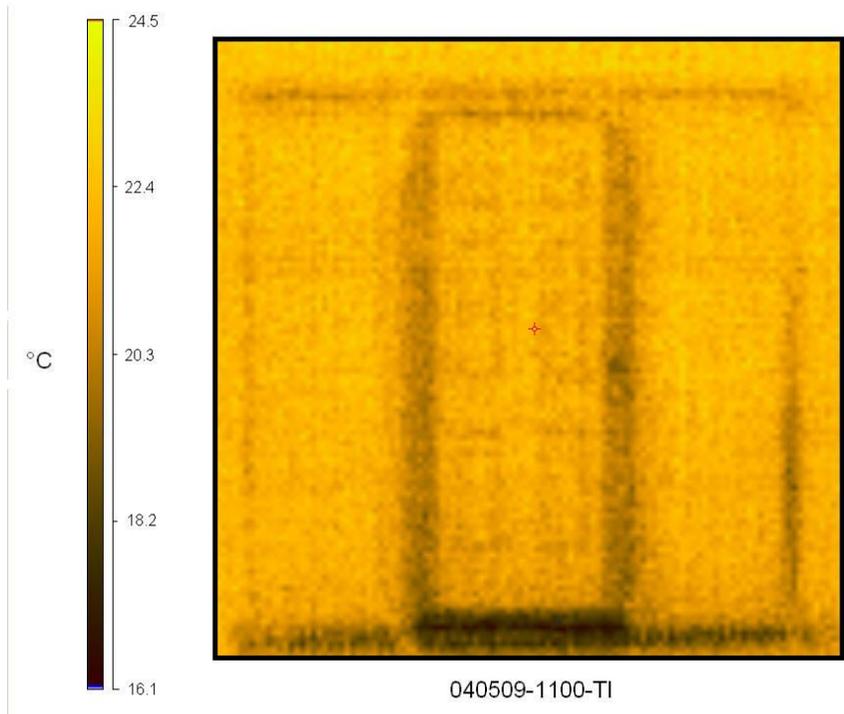
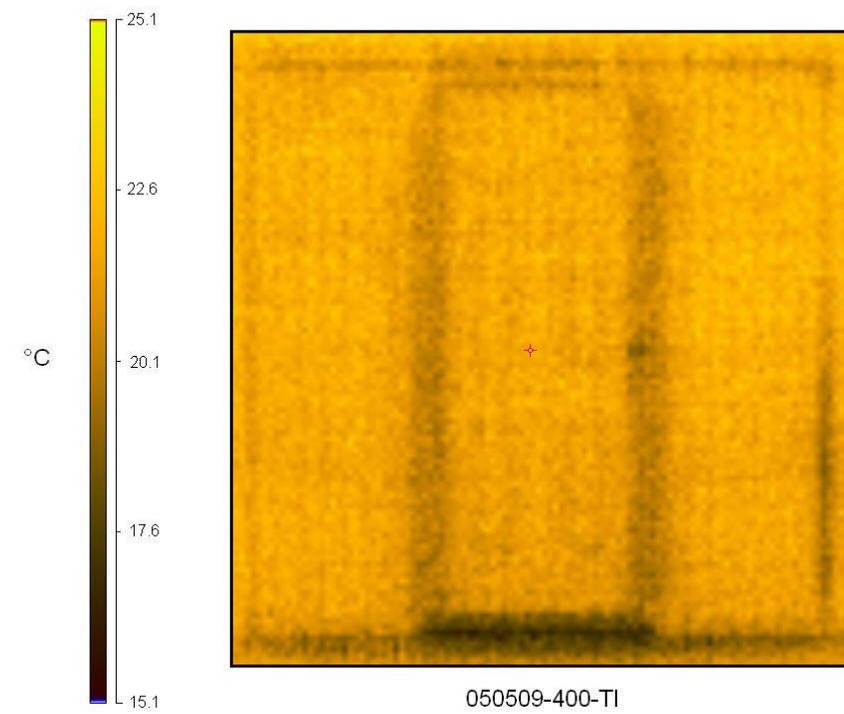
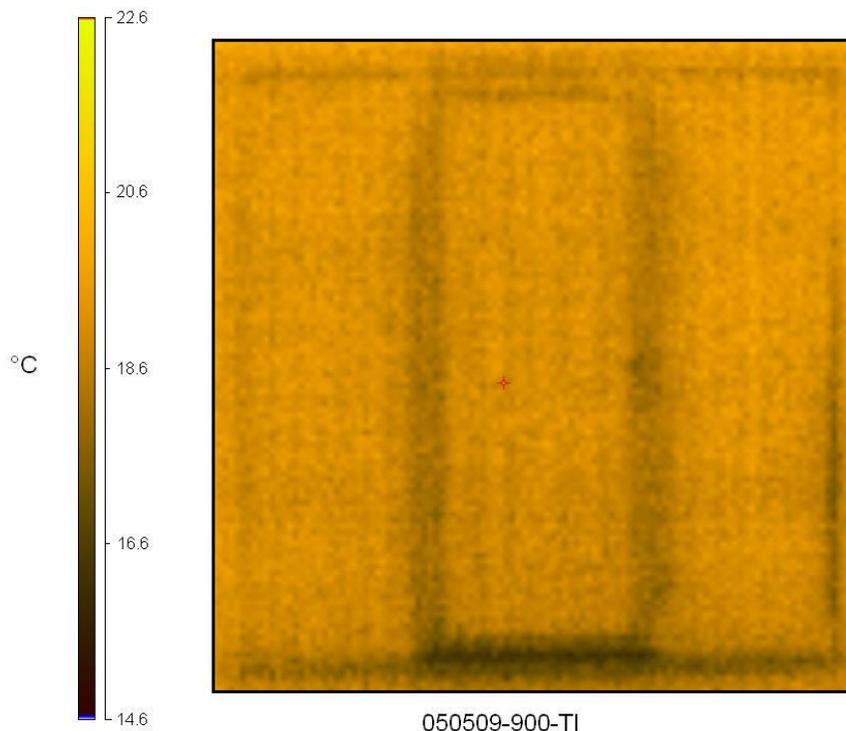
6 Thermal Imaging Camera Pictures (page1 of3)

On separate occasions throughout the testing procedure thermal imaging picture were taken. These pictures illustrate the temperature differences between the door slab and the wall. The most notable area of temperature loss was found along the stiles of the door slab and sill.

Thermal Imaging Camera used: **Raytek Thermo View Ti30 - High performance Thermal Imager**
